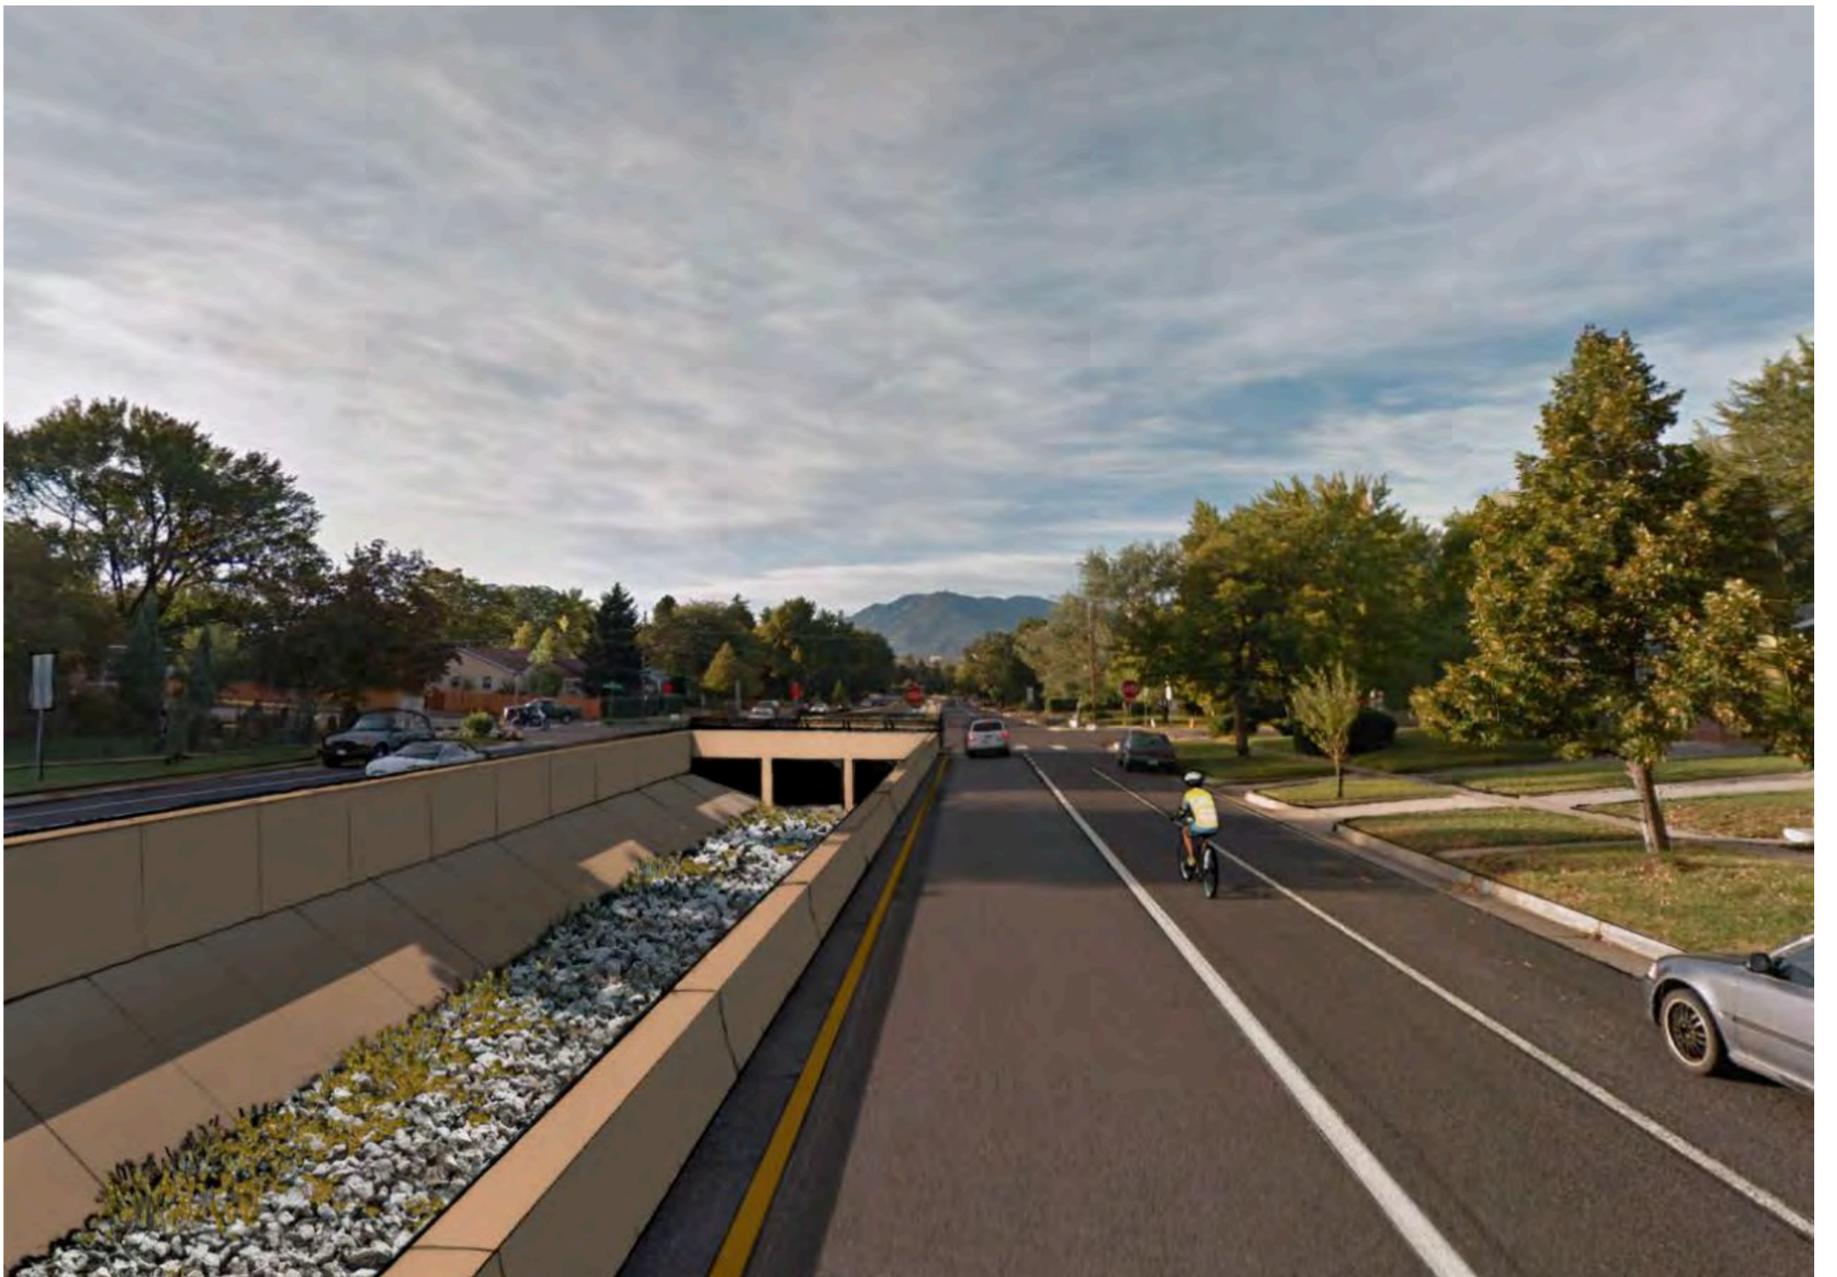
Concept A - Channel Reconstruction along 31st Street

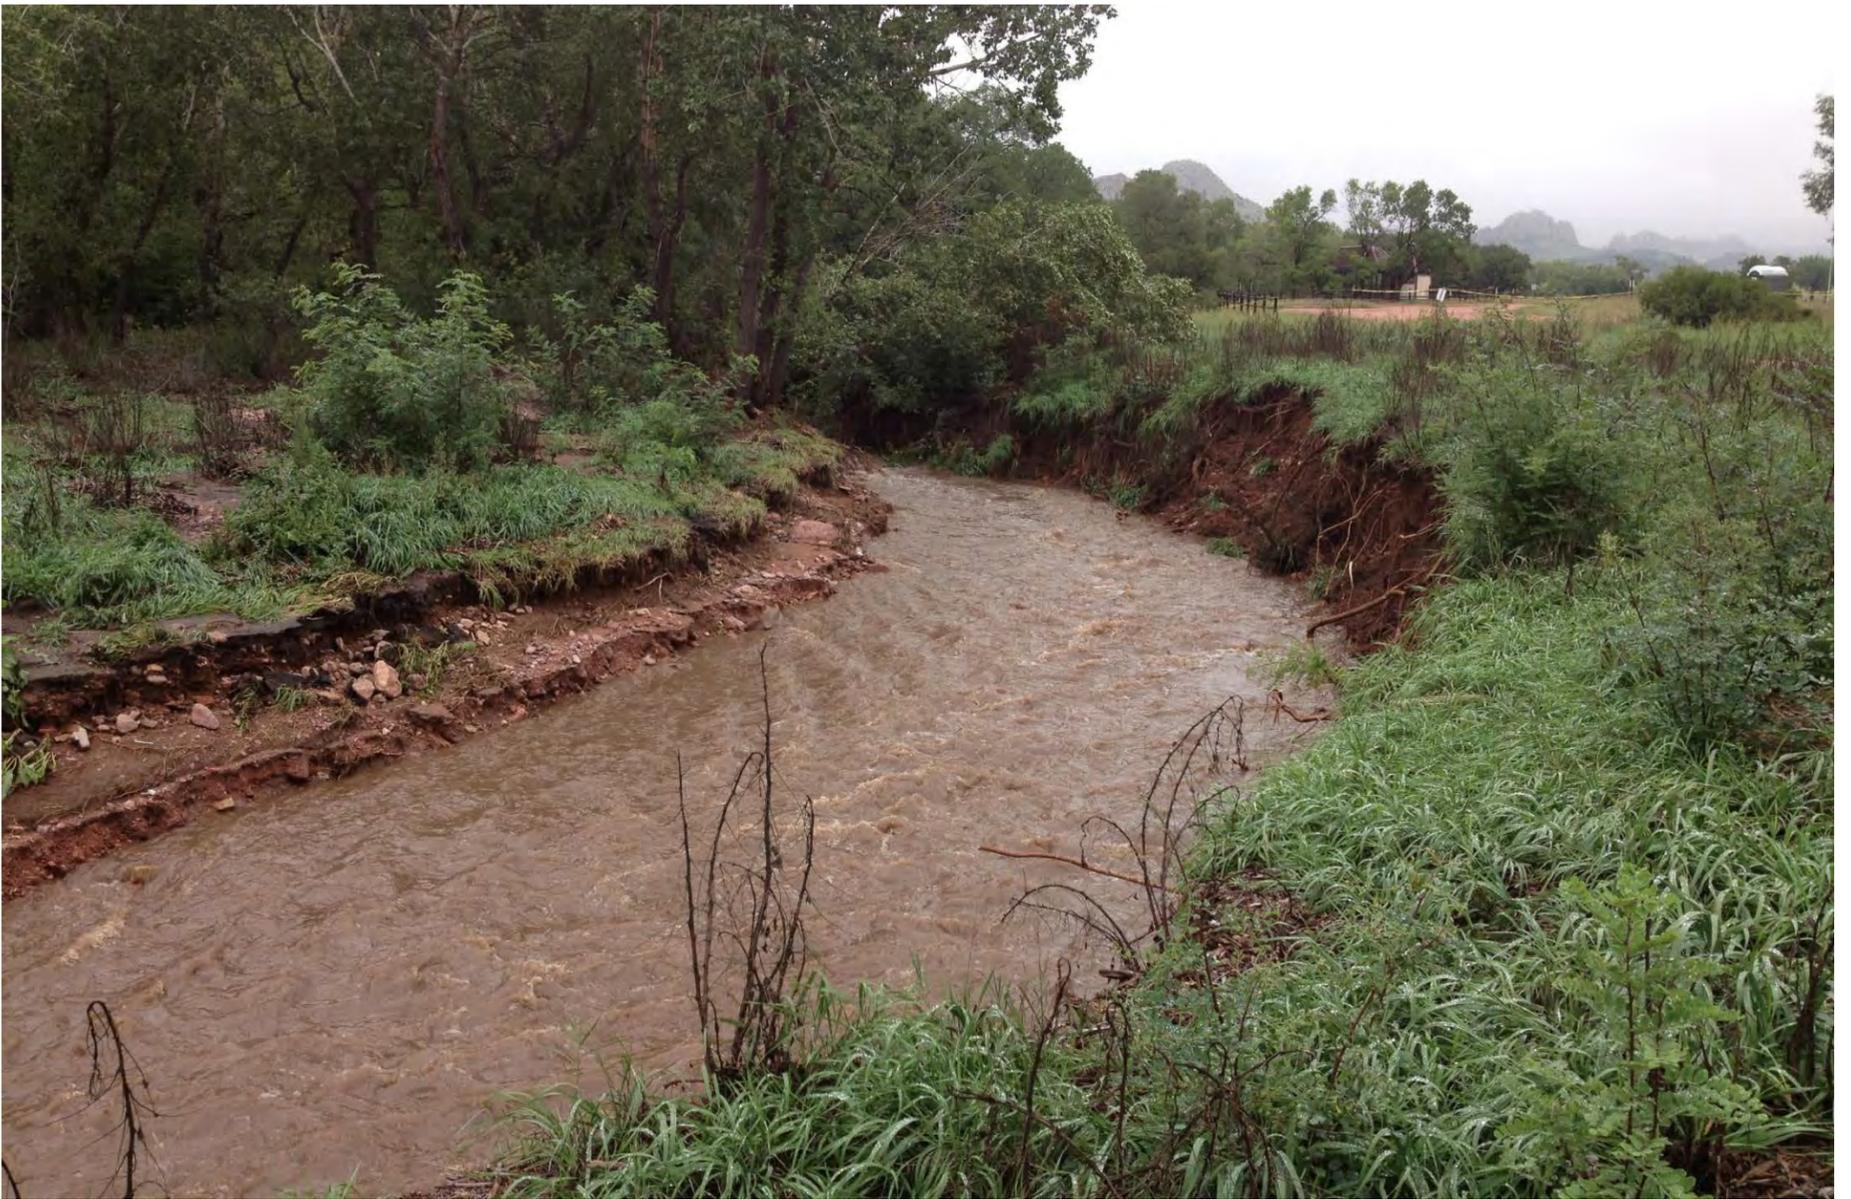
Existing Camp Creek stream channel after September event

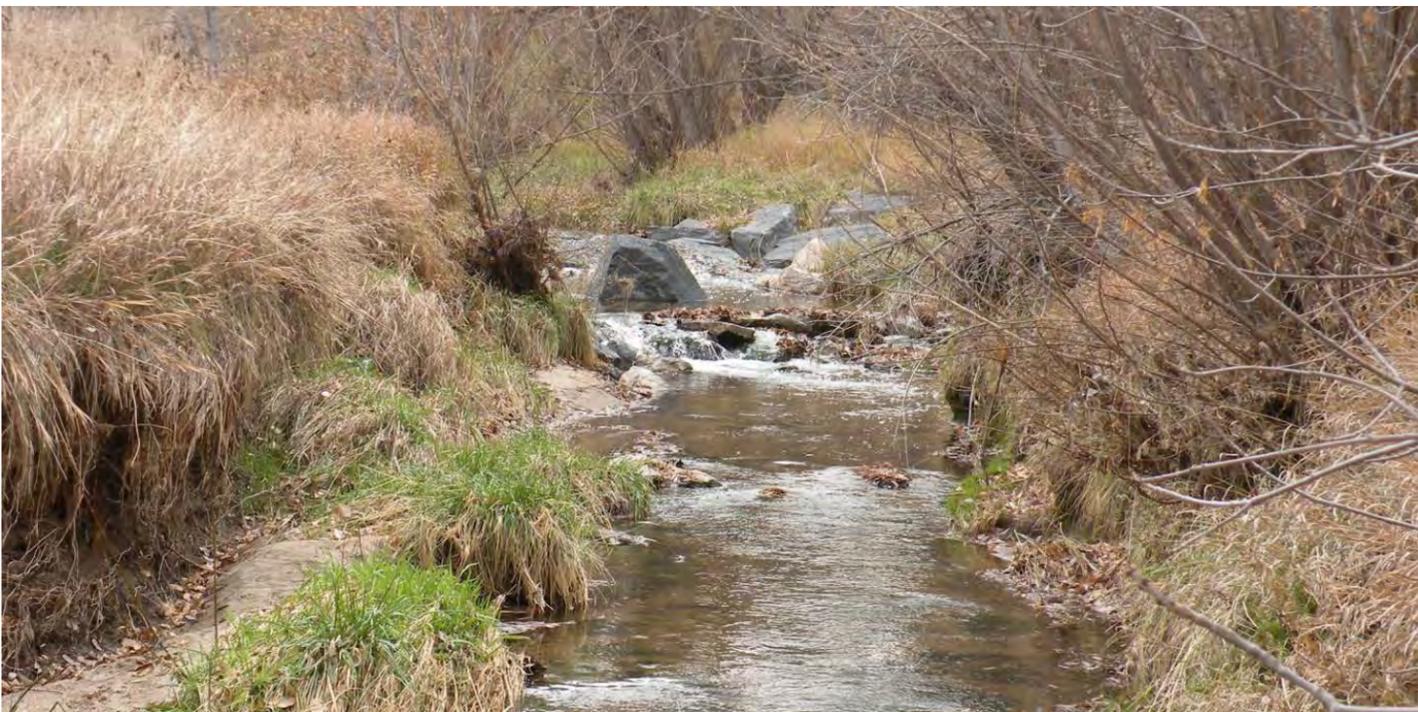
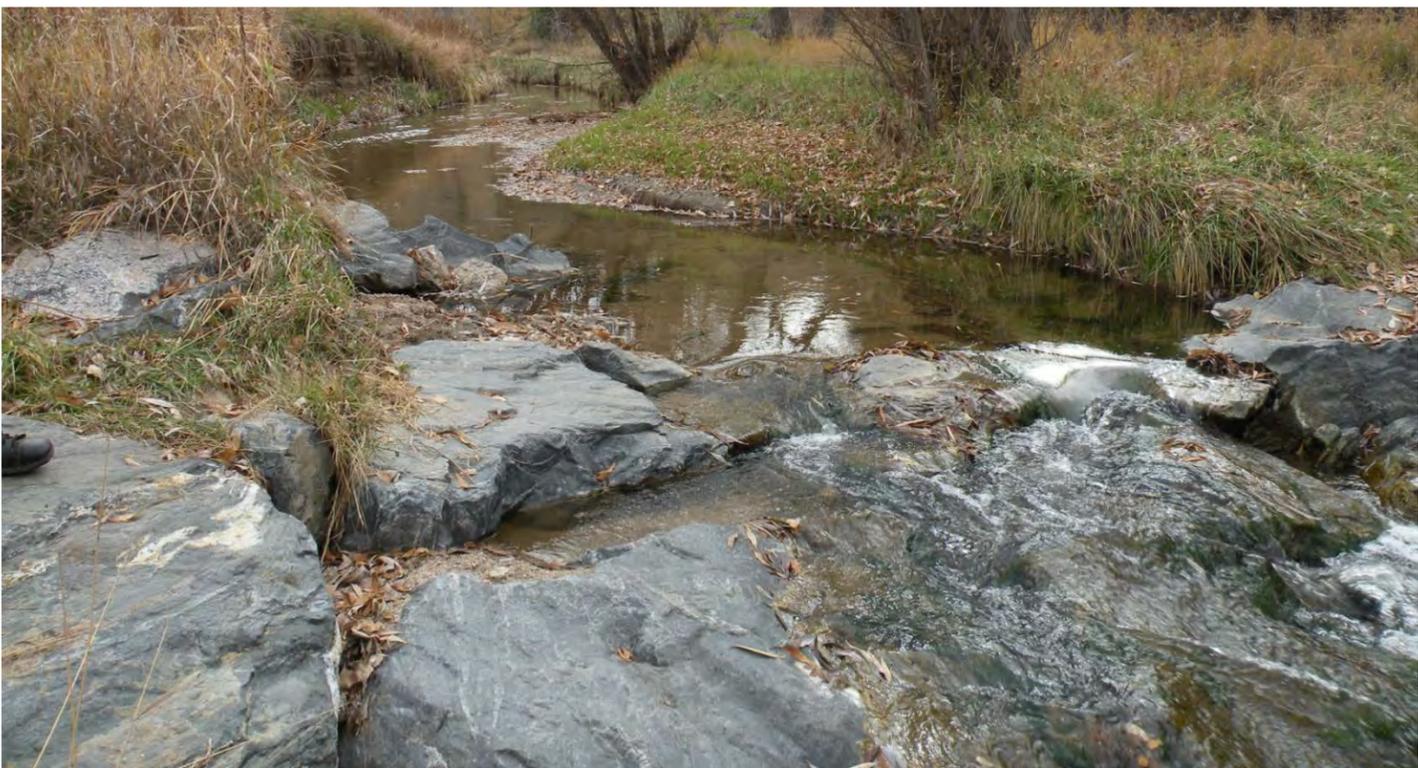
Concepts A, B, C, D and E - Camp Creek Stream Channel Stabilization

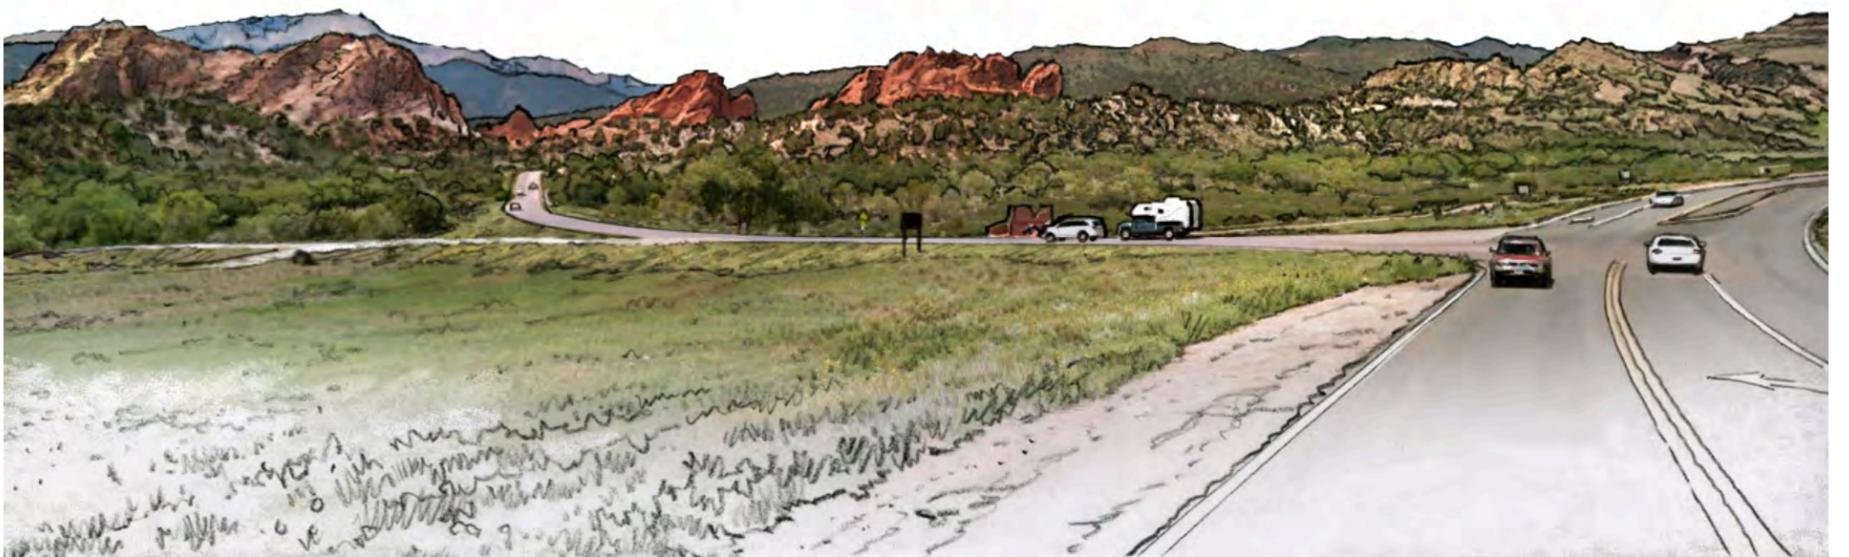
Concepts B, C and E - Gateway Road Embankment as viewed travelling north on 30th Street

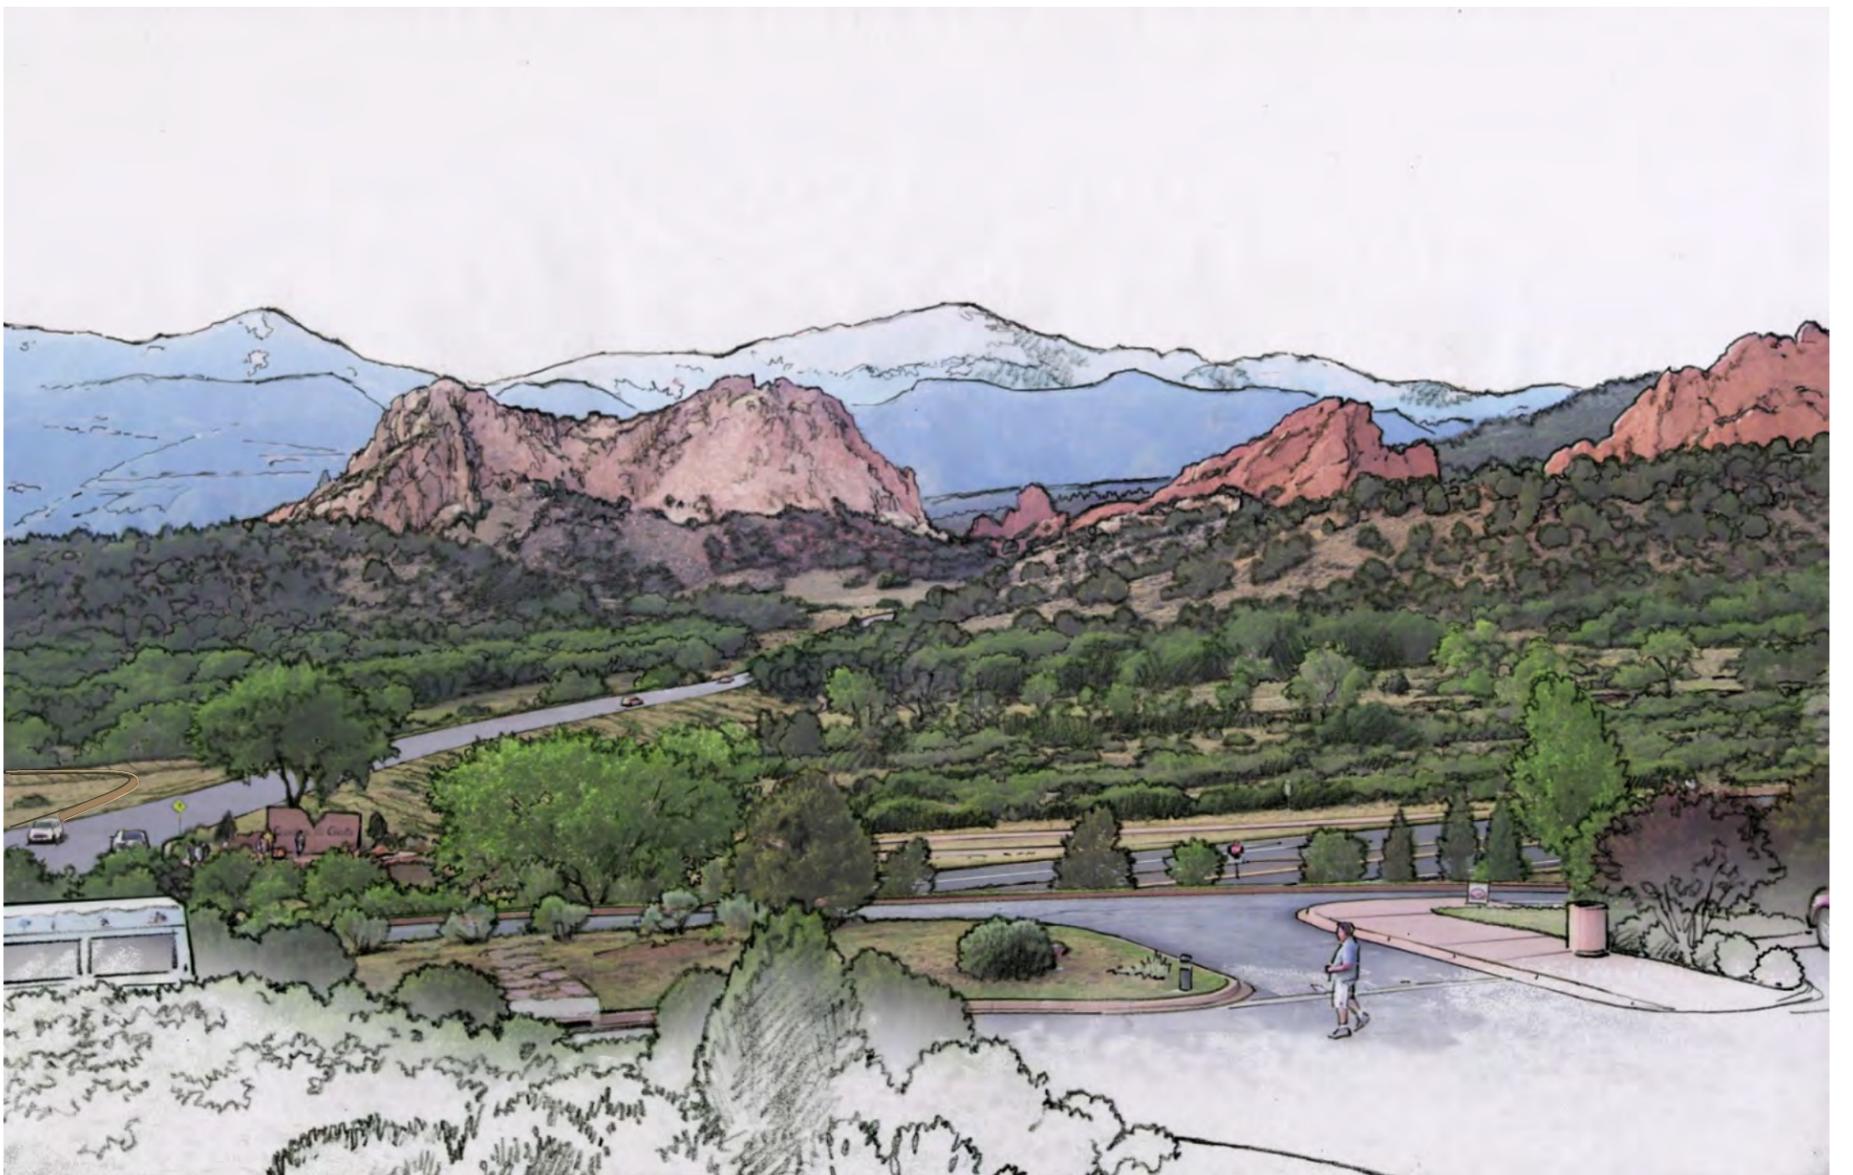
Concepts B, C and E - Gateway Road Embankment

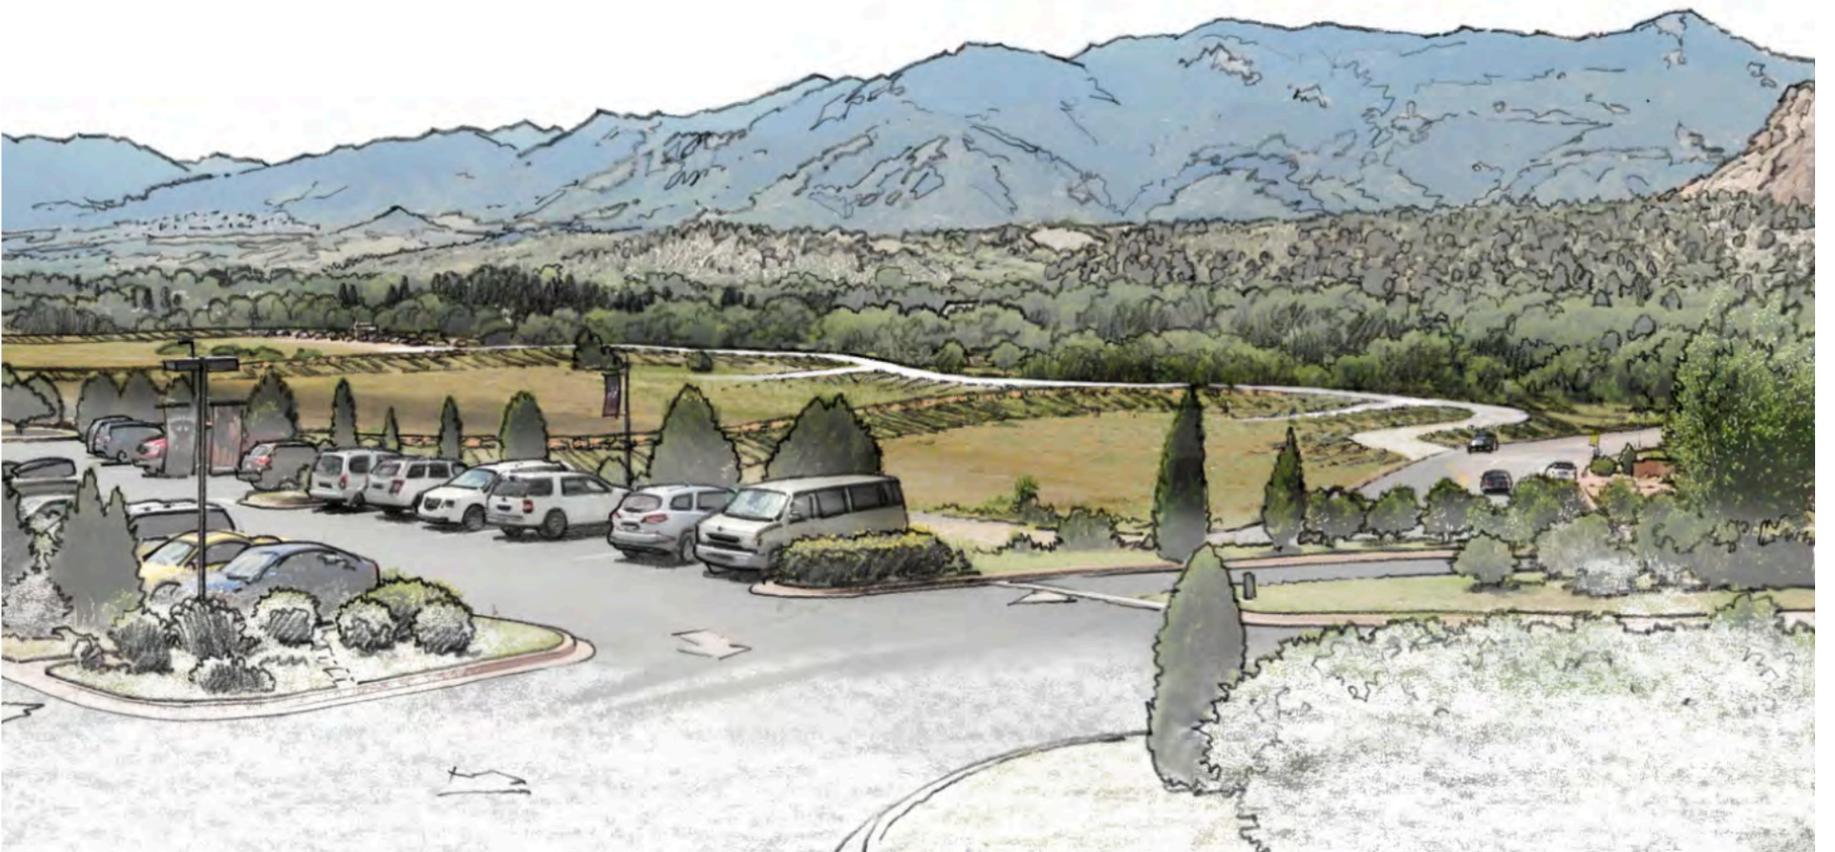
Concepts B and C - Rock Ledge Ranch parking area detention viewed from Garden of the Gods Visitors Center Balcony

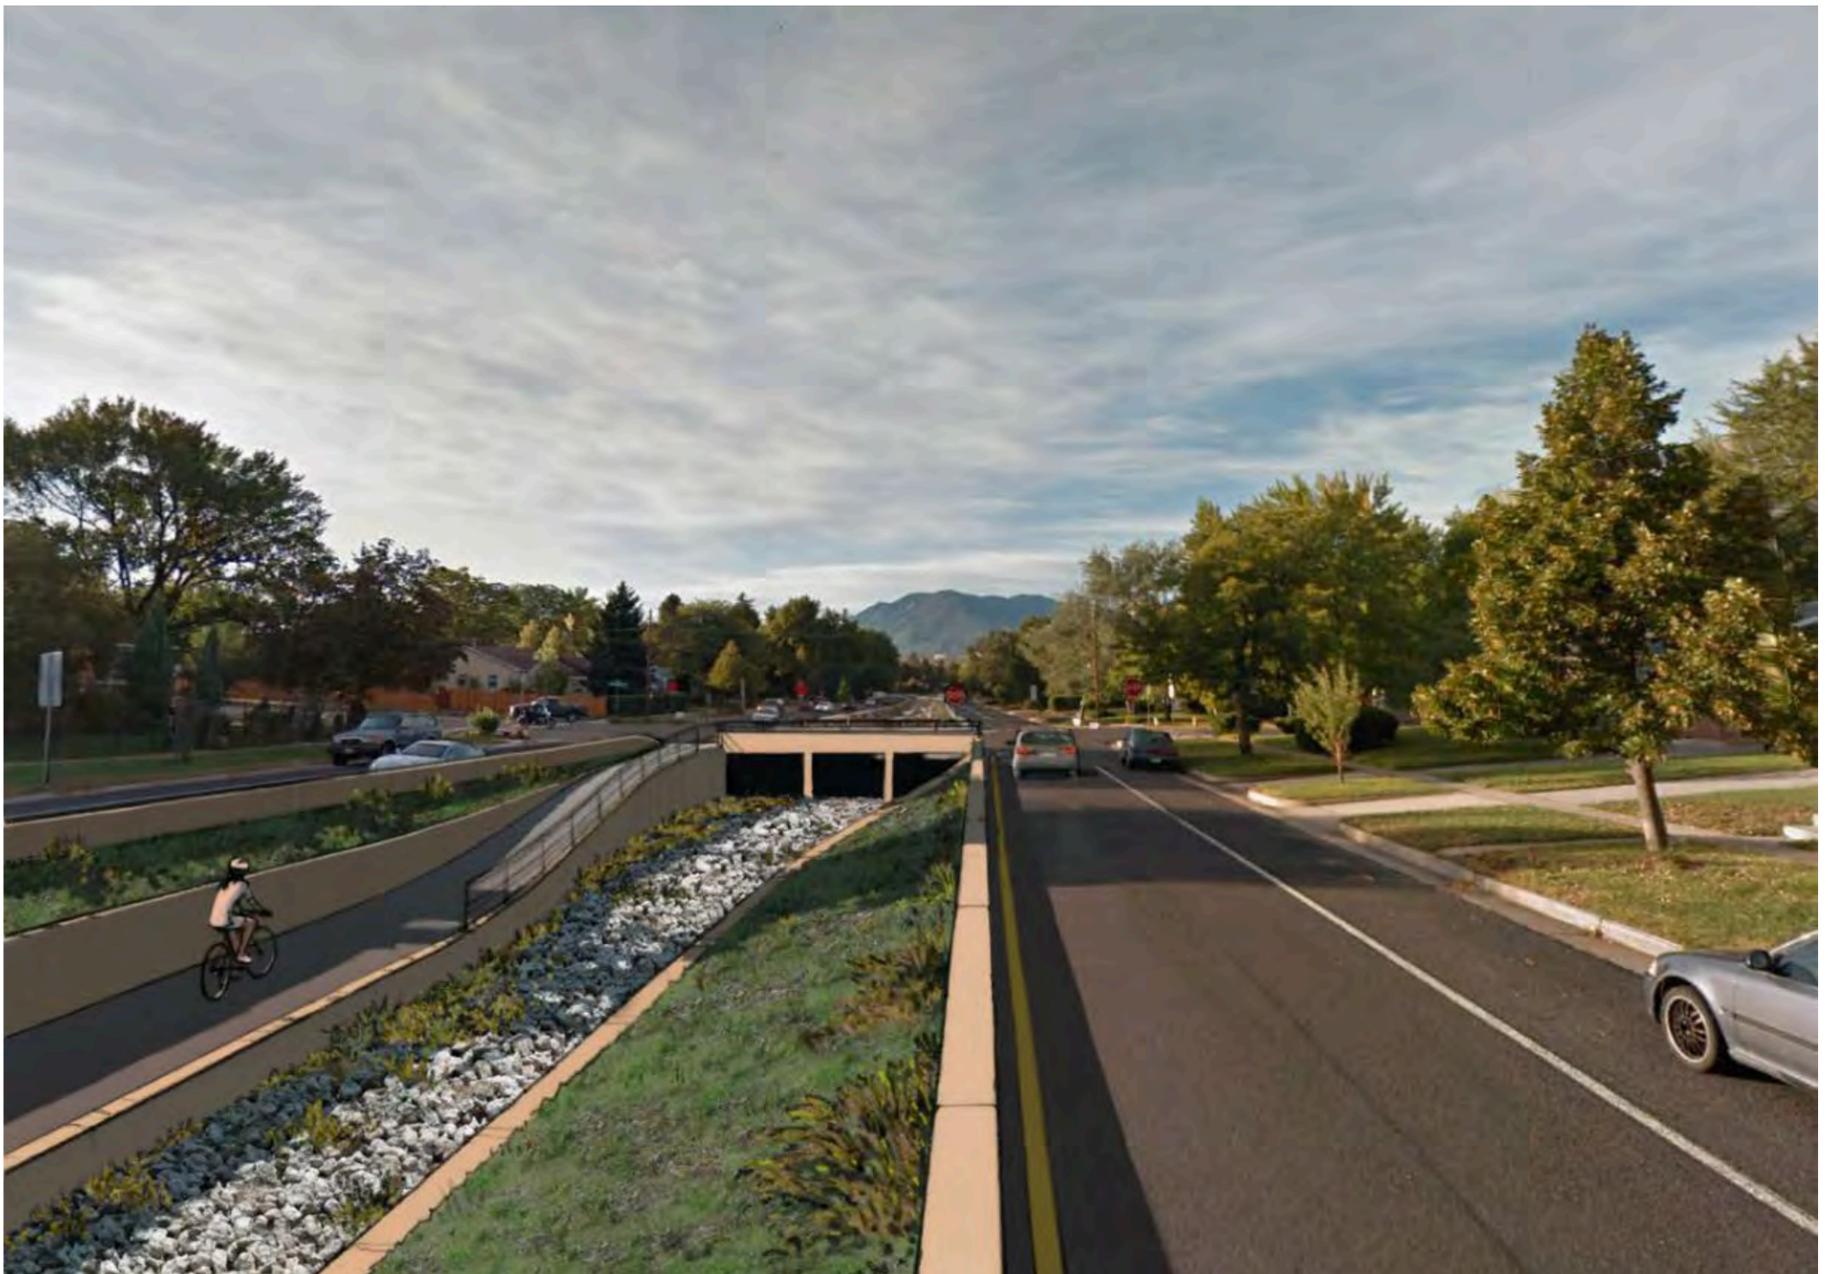
Concept C - Grass-lined channel and multi-use trail along 31st Street

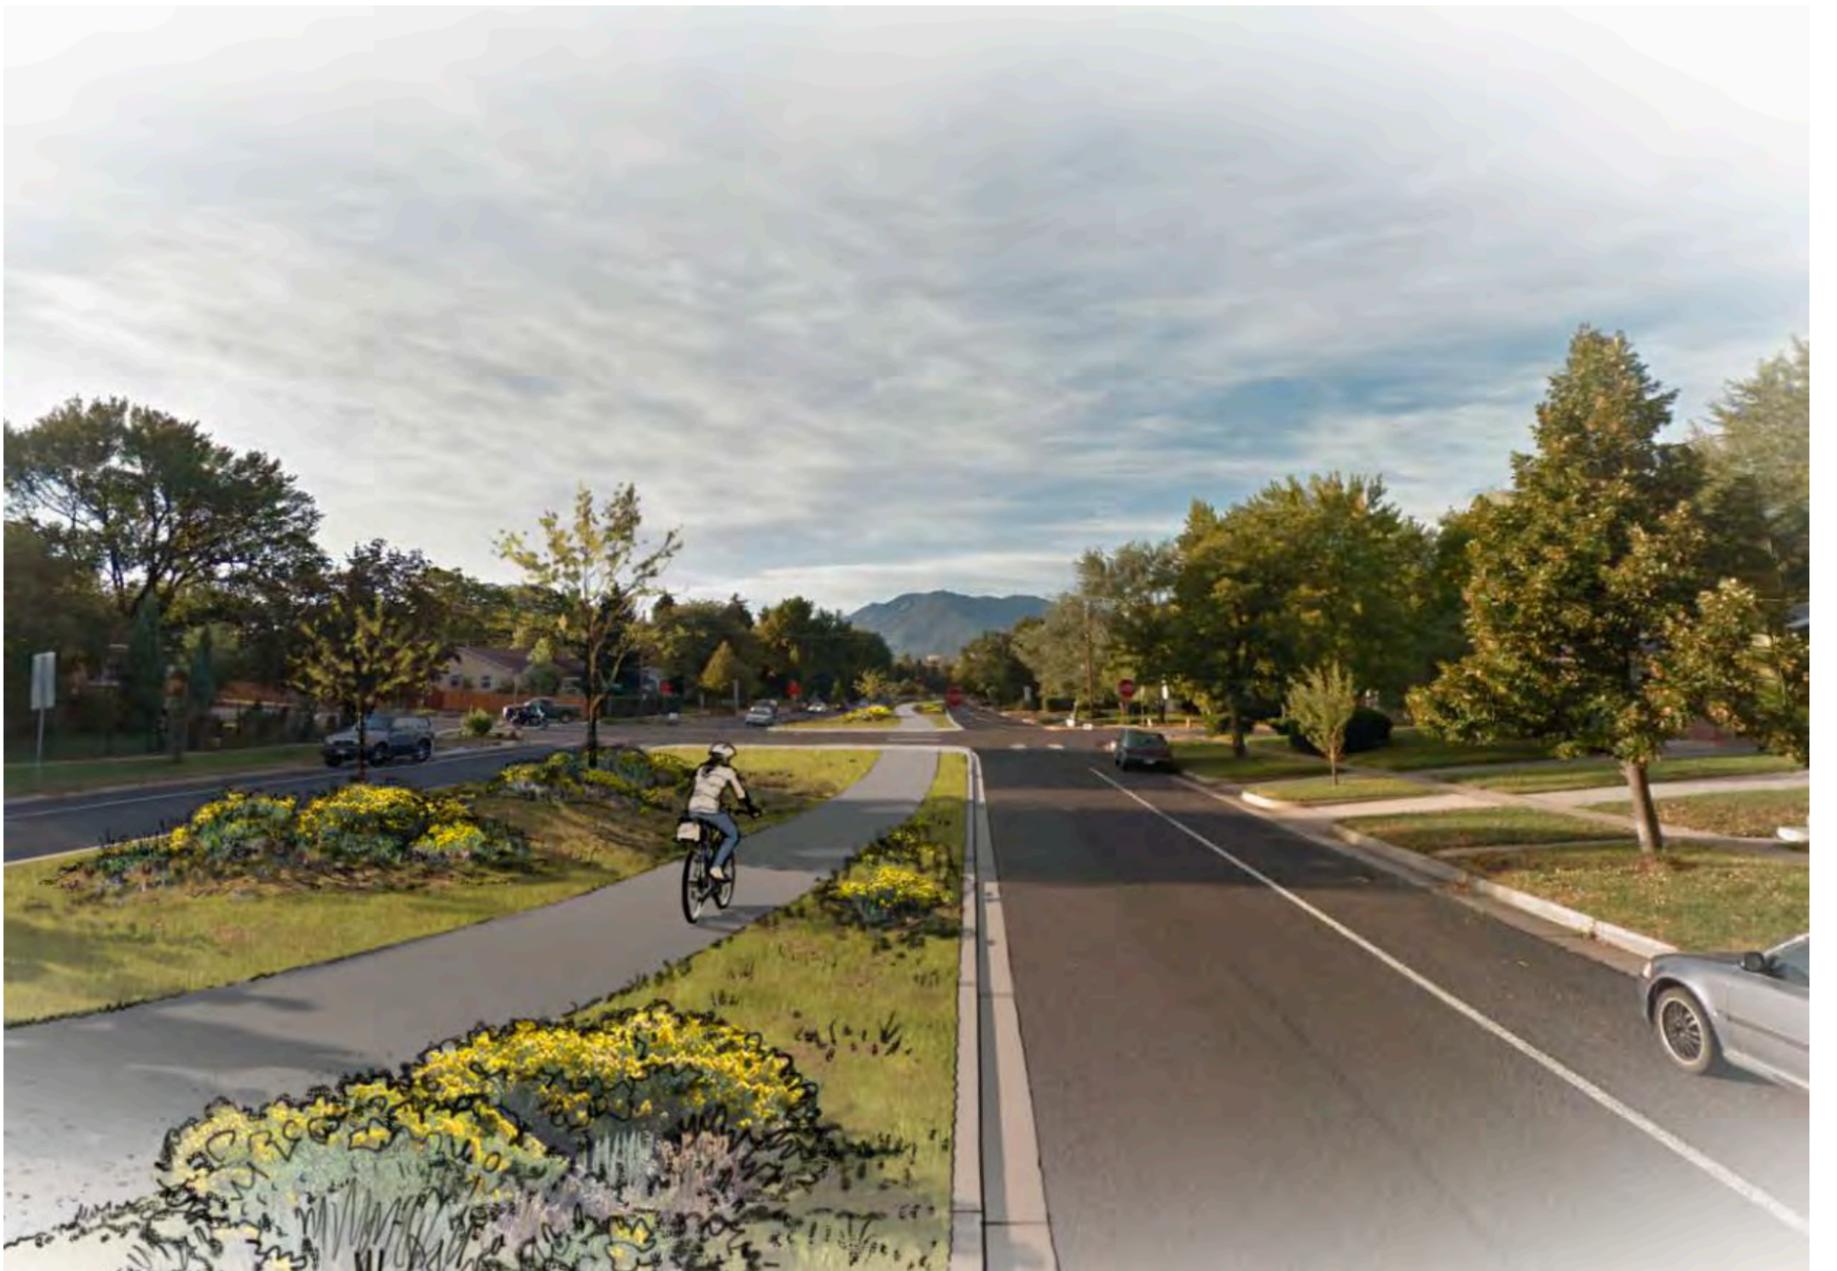
Concepts D and E - Full Median along 31st Street

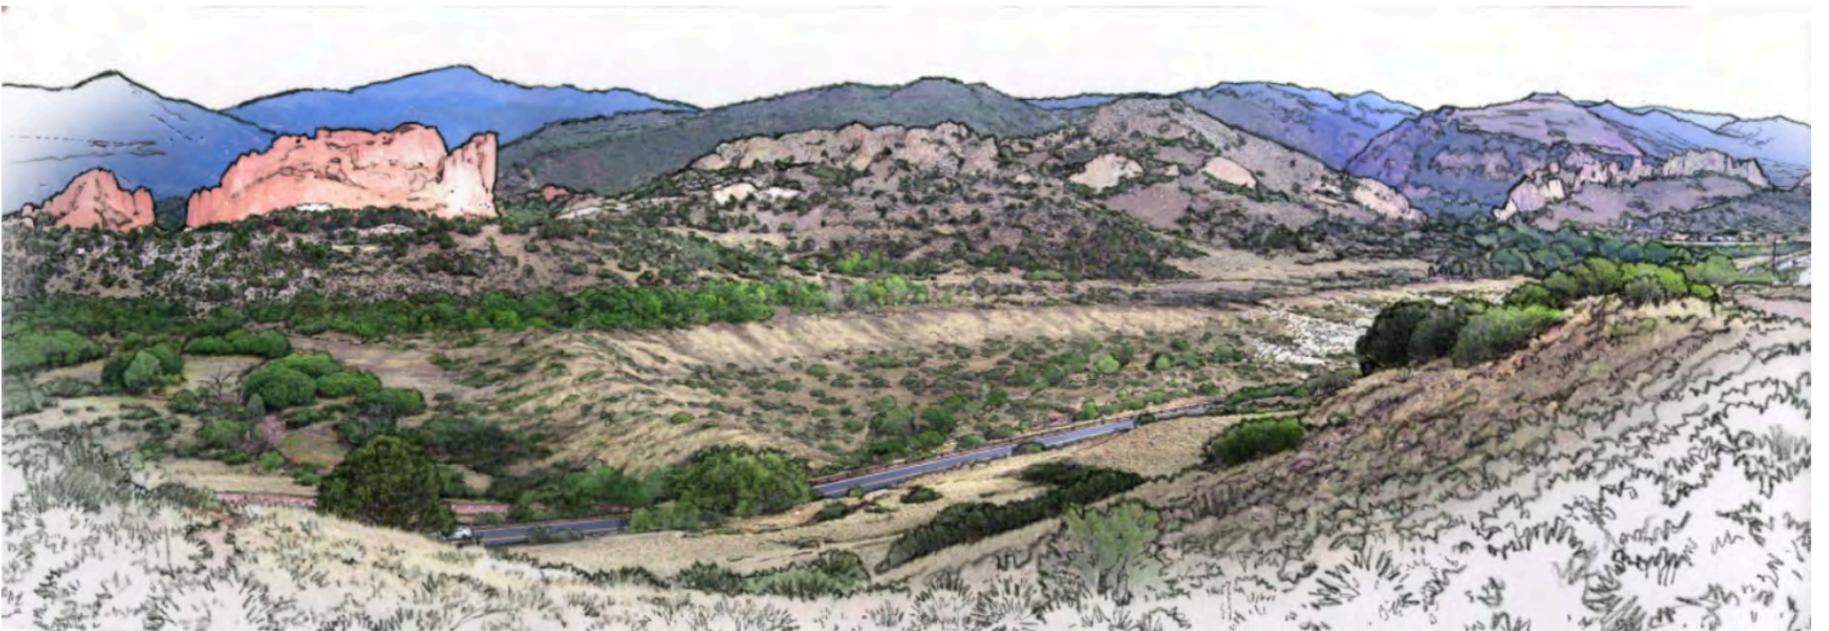
Concept E - Sediment Management Area and Detention in north portion of Garden of the Gods
Concepts A, B, C and D - Sediment Management Area in north portion of Garden of the Gods
viewed from Mesa Road Overlook
